LMSC-HREC TM D784644

STUDY OF NSI AND RELATED  
CABLE PERFORMANCE DURING  
TESTS PERFORMED IN THE  
NASA HOT GAS FACILITY

January 1982

This report documents the tests performed on various cable configurations to evaluate the Nozzle Severance, Insulated (NSI) and other cables inside the Space Shuttle Solid Rocket Booster (SRB) aft skirts. The work was performed under Contract NAS8-32982, "Solid Rocket Booster Thermal Protection System Material Development." The NASA Contracting Officer's Representative for this work is Mr. Bill Baker, EP44.

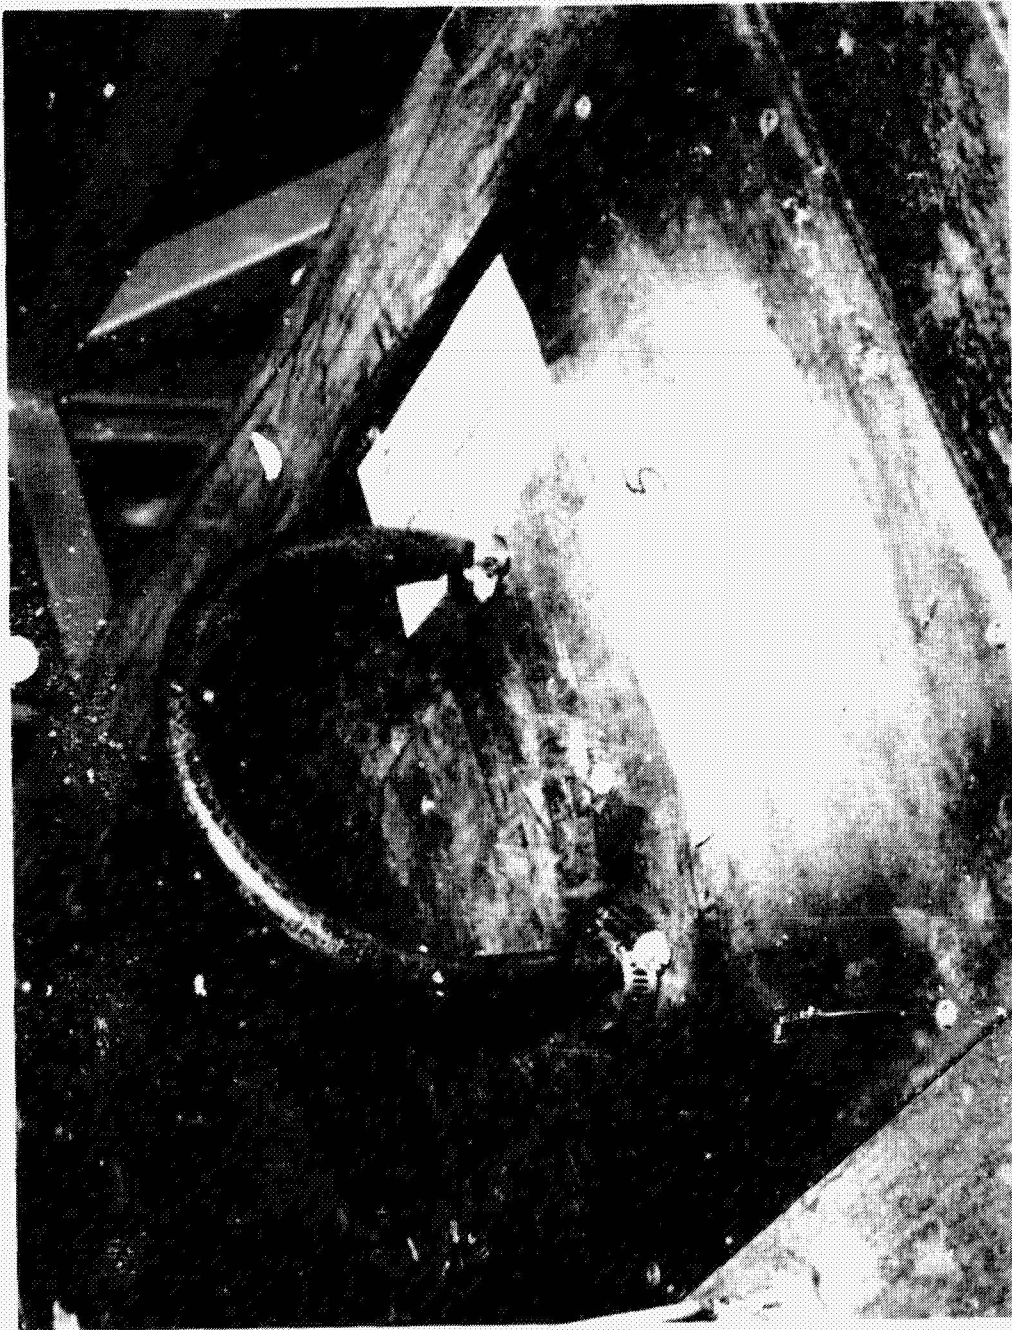
The cable test models were built on test panels and all, except one, were mounted in Test Position 1 of the Hot Gas Facility test section where the clean body heating rate is the lowest attainable. A typical cable loop model is shown in Fig. 1. It consists of a length of flight cable with a clear plastic sheathing which is layed on a length of cable wrap material called "Blastape II." This tape is simply folded over the cable along its length and this arrangement is mounted on a base plate by means of hose clamps as shown in Fig. 1. The model was subjected to 60 seconds of cold flow during which no damage to the cable or its wrap was apparent. It was then subjected to 6.03 seconds of hot flow which failed the insulating Blastape and exposed the cable as shown in Fig. 2.

Fig. 1 - Cable Loop Model Showing the Looped Cable Wrapped  
with Blastape II Mounted on HCF Test Panel

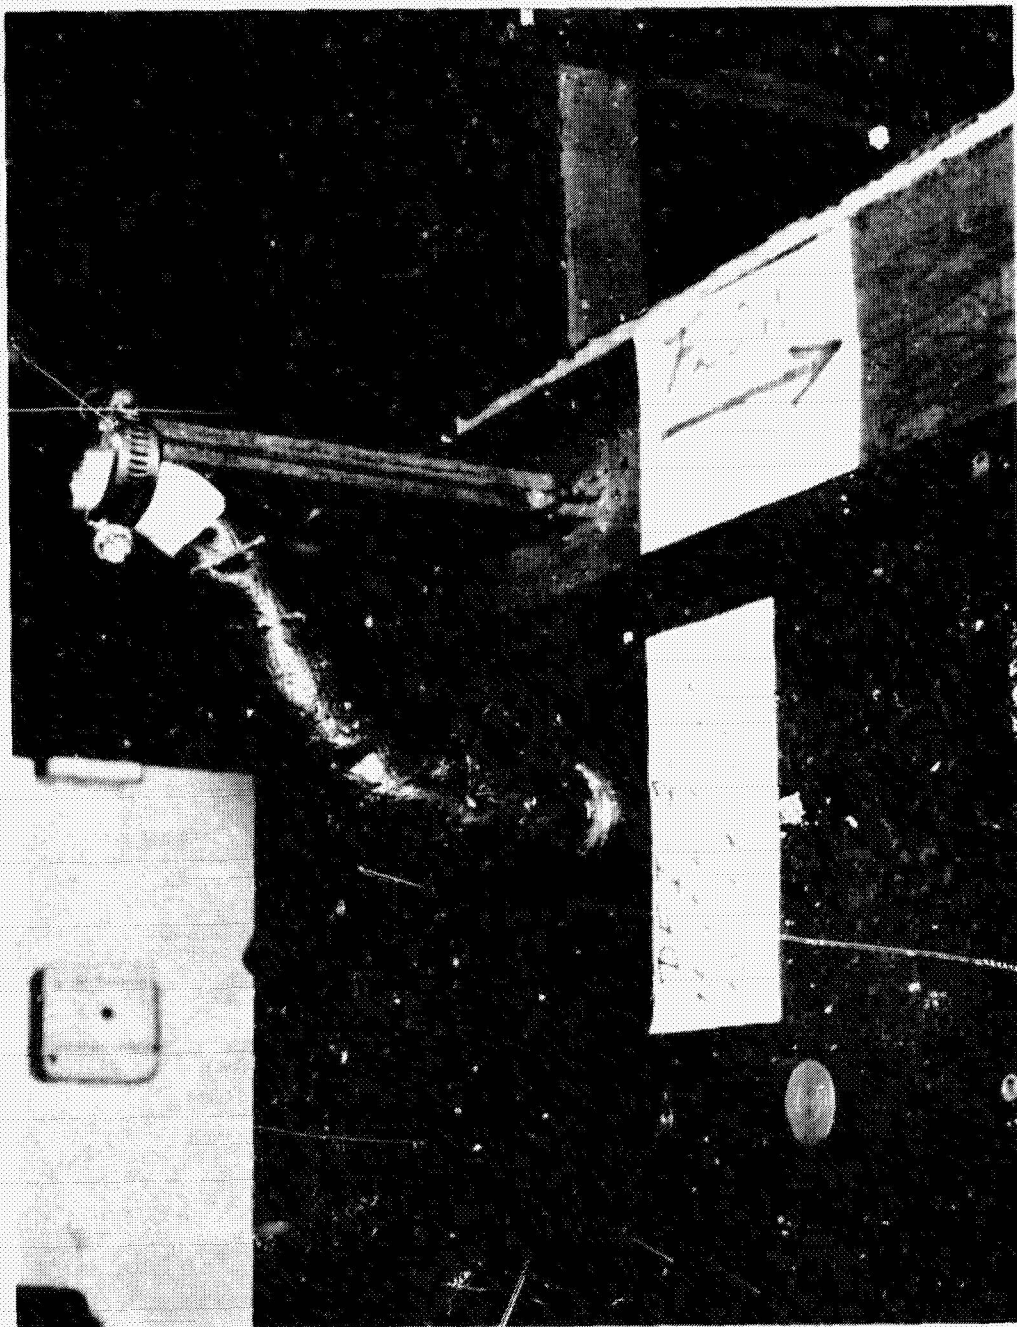
Figure 3 shows a short length of flight cable and connector, both wrapped with Blastape. The tape is wrapped spirally around the connector first and then on to the cable with at least a 50% overlap of the tape material. The connector is mounted in the base plate and the other end of the cable is fastened to a small vertical bracket. This model was also exposed to 60 seconds of cold flow and then 6.04 seconds of hot flow. It is theorized that the top end of the cable broke loose first allowing the cable to flap in the flow and thus causing the entire wrapped material to be lost at once (See Fig. 4). Another model of the same configuration was made up with the end of the cable fastened more rigidly as shown in Fig. 5. The results, however, were similar as shown in the post-test picture of Fig. 6.

Fig. 3 - Short Length of Cable and Connector  
Wrapped with Blastape II

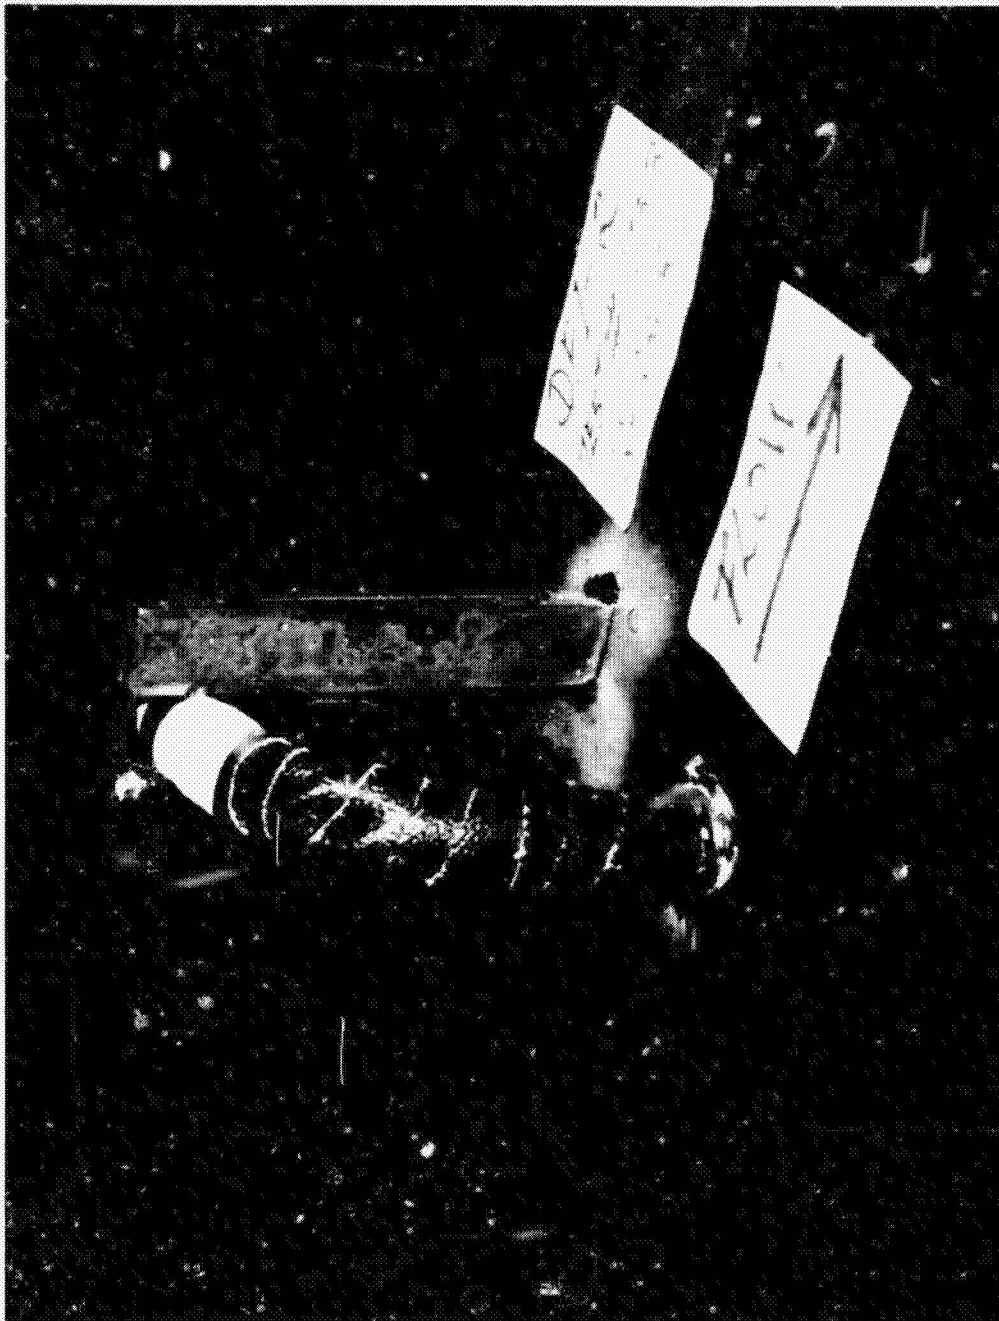
Fig. 5 - Test Model of Cable and Connector Wrapped with  
Blastape II with a Different, Firmer Fastening  
Method for Cable at Top End

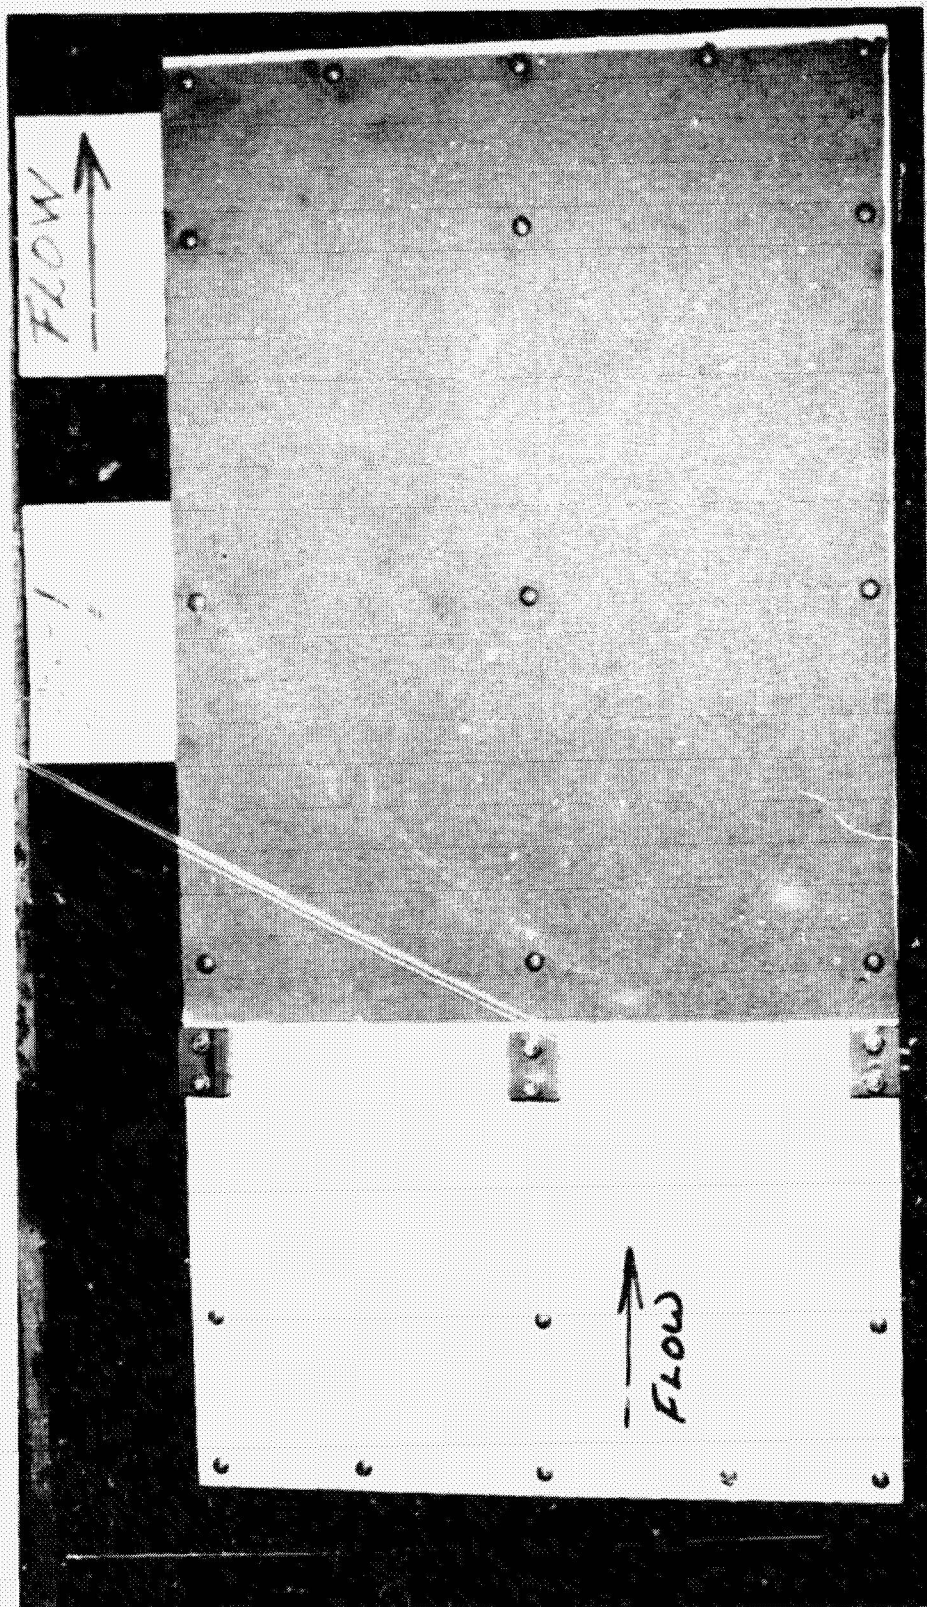
To simulate yet another area of the NSI cables in the aft skirt, a model shown in Fig. 7 was made up. It consisted of two 1/8-in. diameter flight type cables spaced 1/2-in. apart and clamped between steel blocks at

a representative distance apart on a flat aluminum panel partially protected with cork. After 26 seconds of test, when the run had to be terminated due to aluminum temperature directly under the cables having reached 400 F, all cork was lost (probably due to faulty bond). The cables looked good but were sagging a little as seen in Fig. 8. This test was repeated and results were the same as far as cables were concerned (see Figs. 9 and 10). Yet another repeat run was made with the exception that the aluminum backface temperature was allowed to rise above 400 F in order to obtain a longer test duration. The result of this test which lasted 50.3 seconds is depicted in the photograph of Fig. 11 where one portion of cable was lost and another was loosened.

Fig. 7 - Typical Aft Skirt Internal Cable Configuration Model (The Cork  
Downstream of the Cables is for Aluminum Panel Protection in  
the Higher Heating Rate Zone of Test Position 1 in HGF)

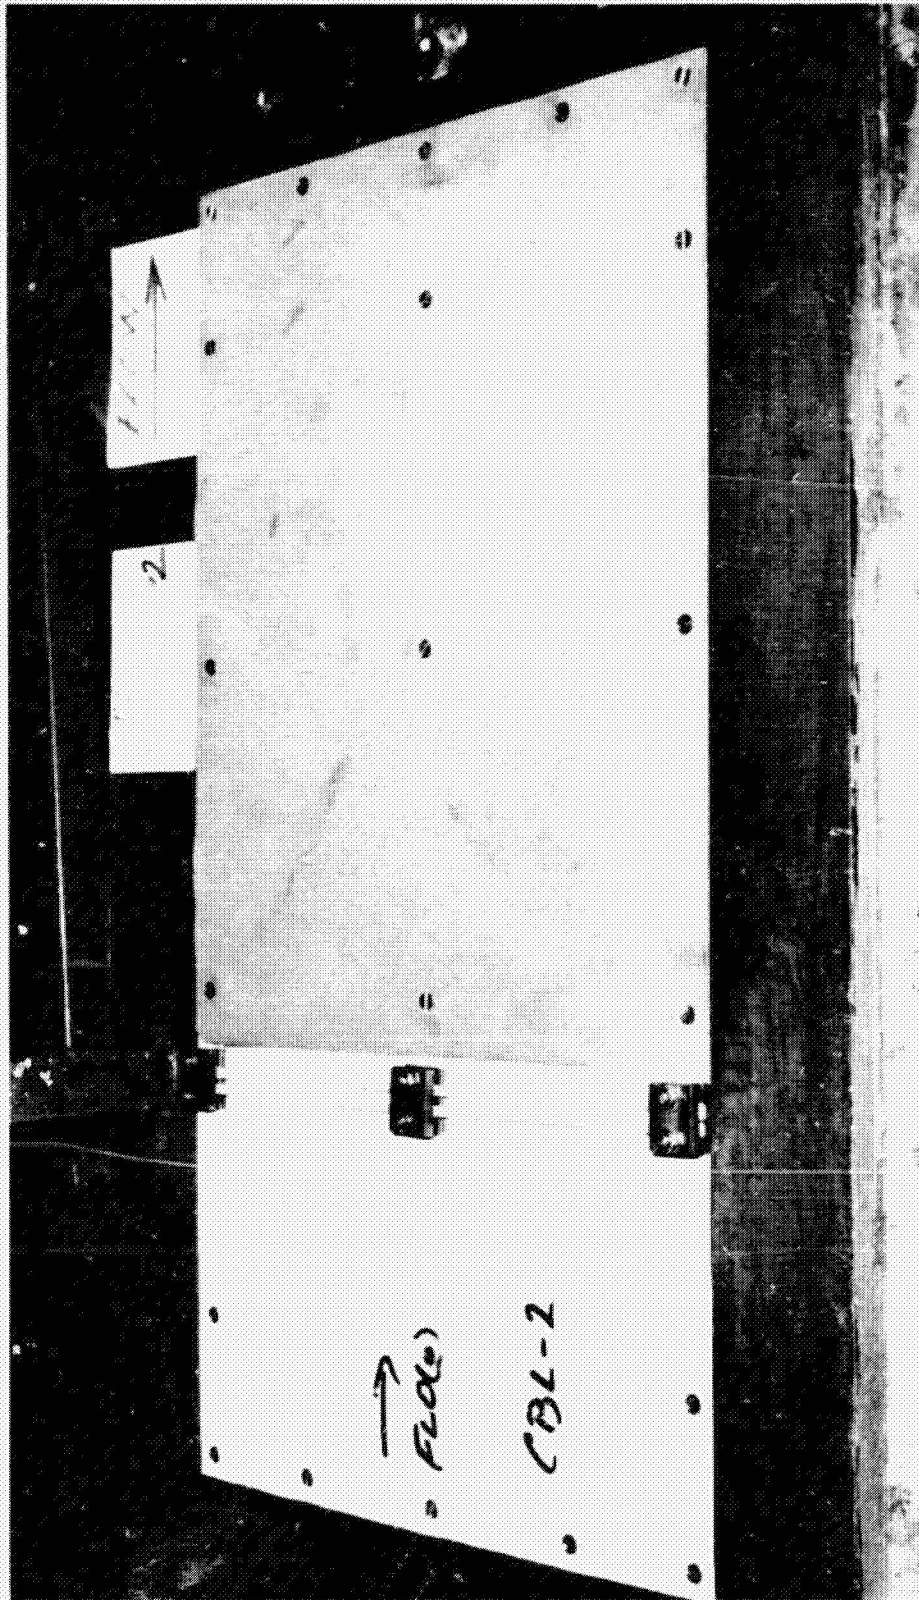
Fig. 9 - Repeat Test Model of Specimen Shown in Fig. 7

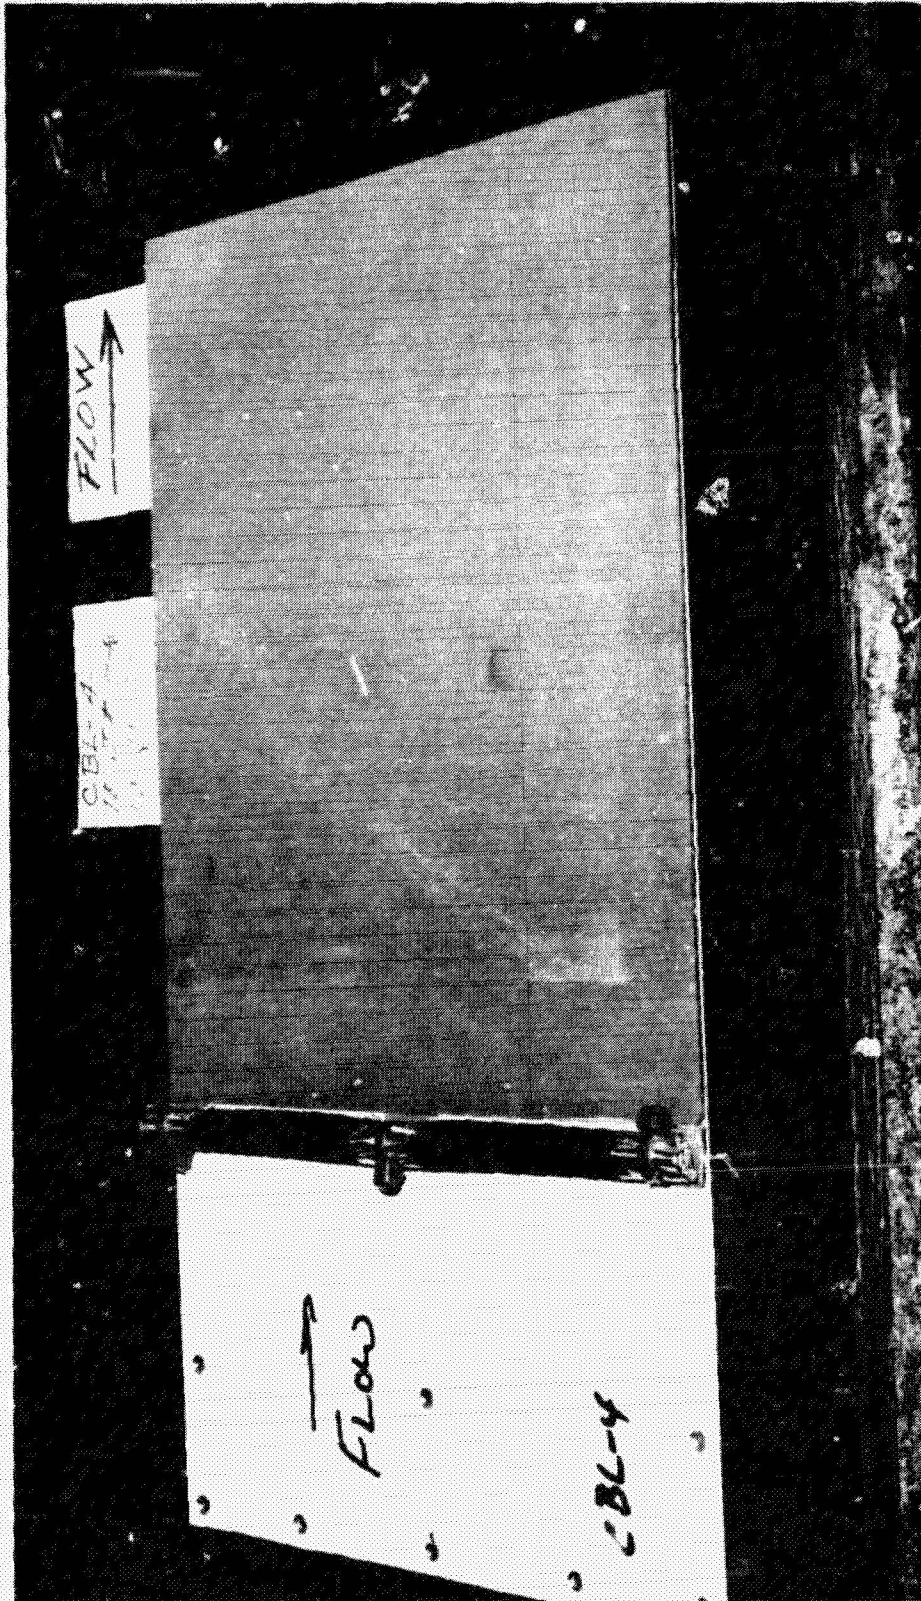
Figure 12 is also a cable model similar to the one shown in Fig. 9. Here the cables are wrapped individually with "Blastape II" and fastened with nylon ties that are bonded with EA 934 to small steel plates bolted to the aluminum base. A post-test picture of this model is shown in Fig. 13. The two cables shown here were recovered later after the test. The clamps could not be found and are believed to have disintegrated due to the heat early in the test which was run a full 60 seconds (maximum run time in HGF). In order to find a solution to the problem of proper cable mounting technique, the model of cables with Blastape and nylon ties was taken and a ramp of K5NA closeout material was built up over the cables as shown in Fig. 14. This model was run for 60 seconds also and virtually no damage, aside from the normal char formation, was indicated.

Fig. 12 - Cables on Test Panel Protected by Blastape and Fastened  
with Nylon Ties Threaded Through Nylon Bases Epoxied to  
Small Steel Standoffs Bolted to Aluminum Panel

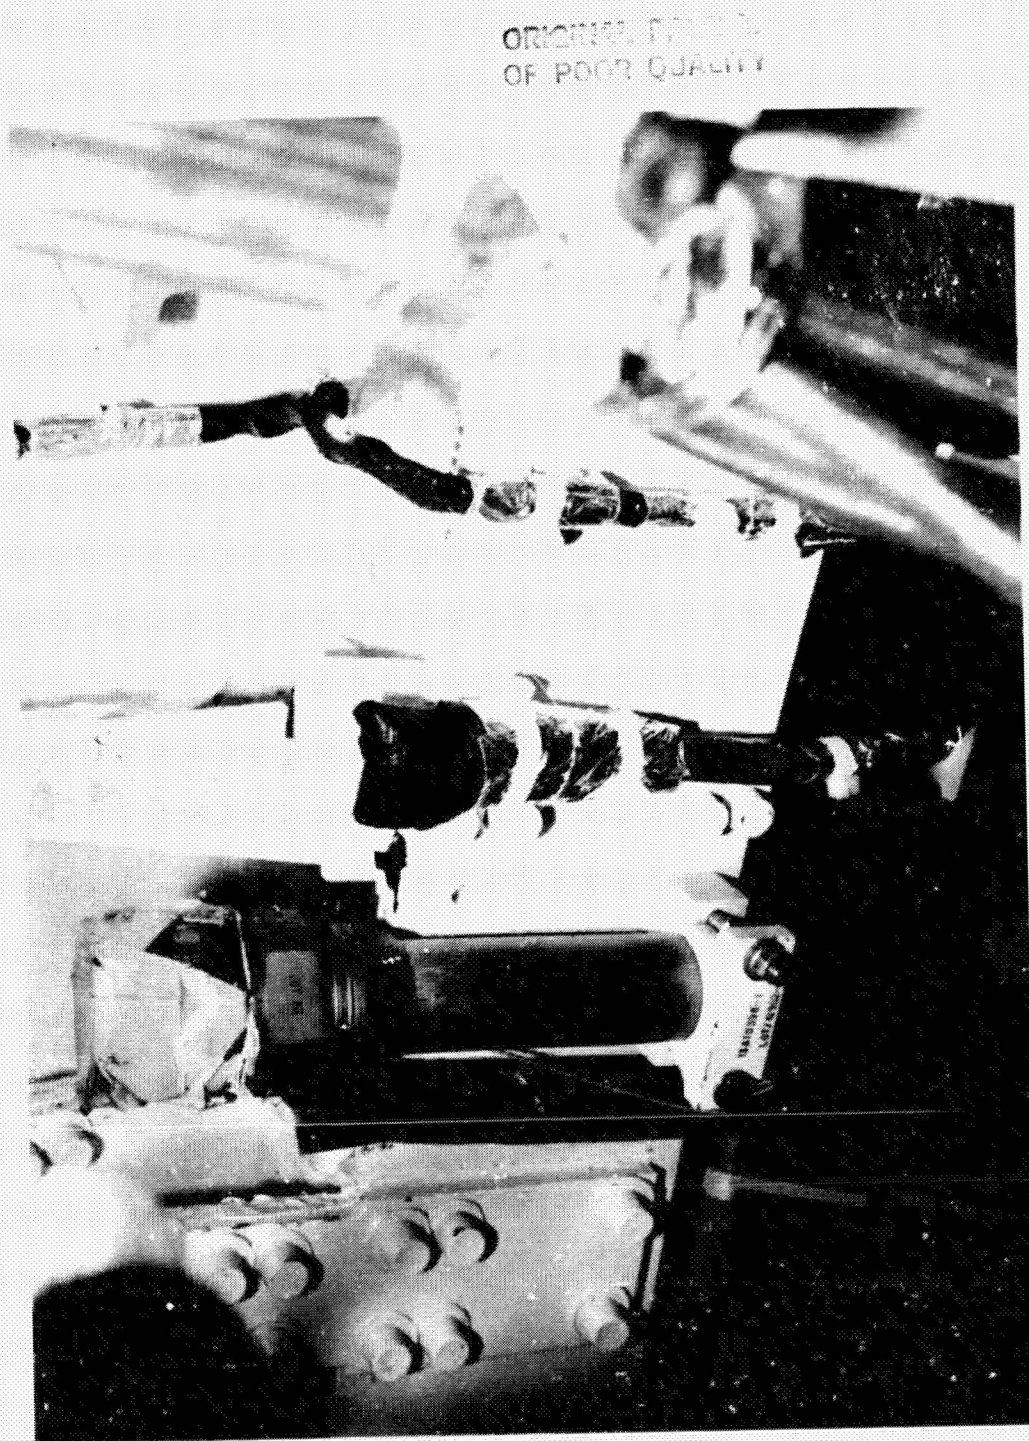
Figure 15 is a photograph taken from inside the aft skirt of A-11 showing a cable routed in a U-shape over the aft skirt aft-ring. This cable configuration is the subject of the next test model shown in Fig. 16. The cable as seen is wrapped with "Blastape II" and routed on the test panel in the manner shown in Fig. 15. It is fastened with nylon ties threaded through nylon bases bonded to the test panel with EA 934. The cork on the downstream half of the panel is to protect the aluminum base plate in the higher heating rate region in the HGF. The cable was lost during the test again because the nylon ties could not withstand the heating. These ties, broken in pieces, are shown in Fig. 17 with the relatively undamaged cable recovered after the test.

Fig. 15 - View from Inside of A-11 Aft Skirt Showing How One  
Cable is Looped over the Aft-Ring Flange

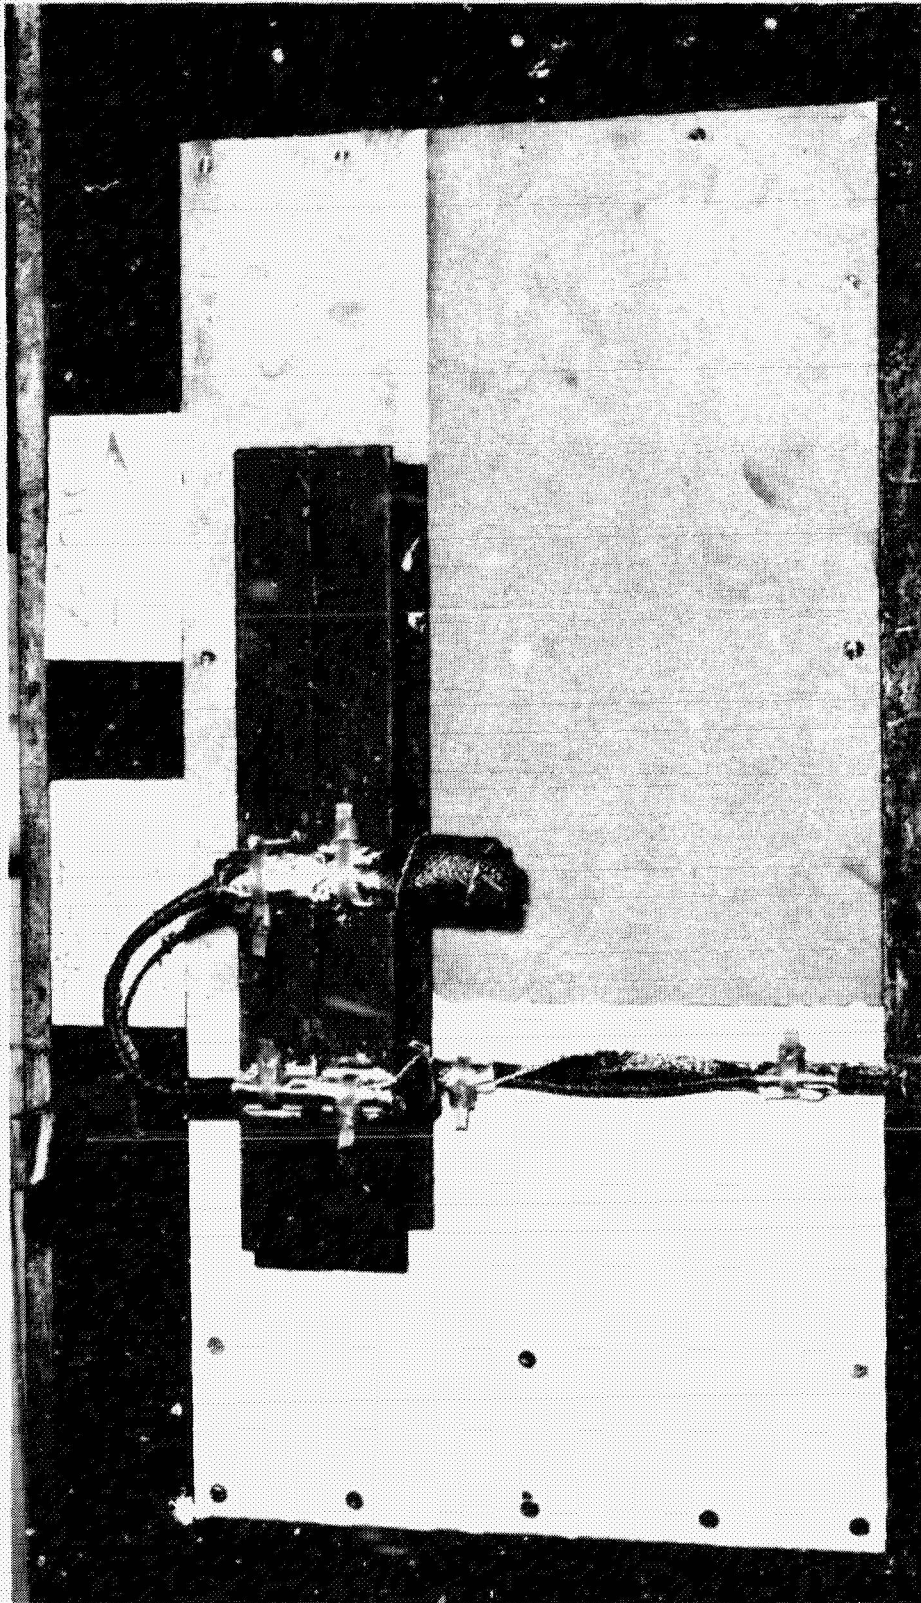
Fig. 16 - Model Prepared to Simulate the Cable Configuration of Fig. 15

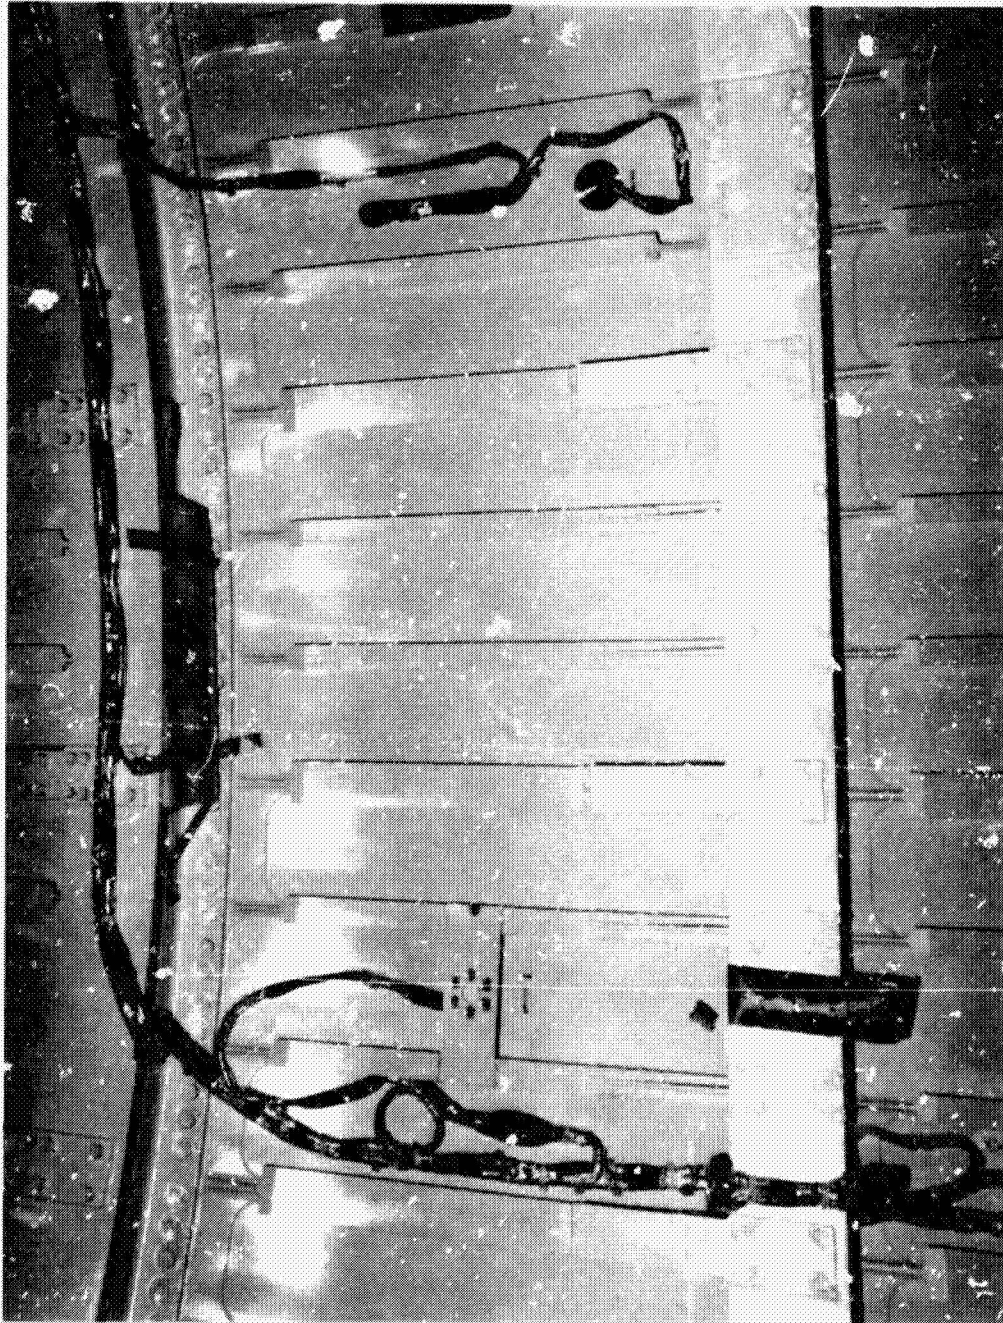
Aft skirt rerouting cables are depicted in the photograph of the inboard surface of A-12 in Fig. 18. This type configuration of cables including the mounting ties and typical spacing between ties was simulated with a cable model built on a flat test panel. Post-test photographs of the model shows that the cable came loose completely from its clamps, a problem encountered in earlier tests (see Fig. 19).

Fig. 18 - Typical Routing of Cables Inside A-12 Aft Skirt

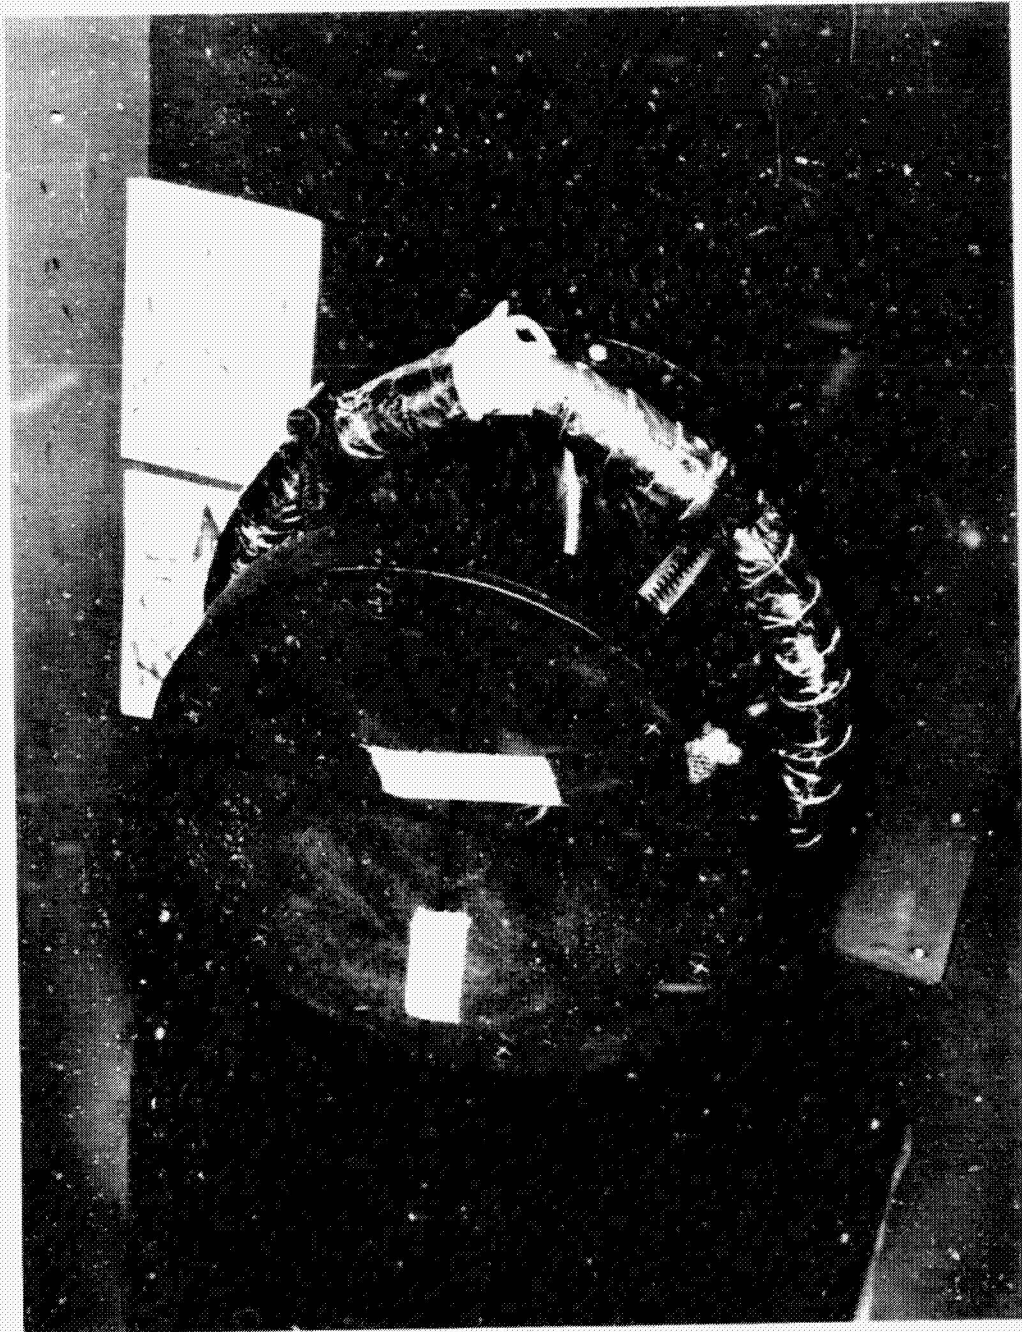
An alternate cable wrap material known as "3M Heat Barrier Tape SJ8000X" was tested. The 3M tape is a very pliable, easy-to-wrap tape as opposed to the thick and hard to spiral wrap "Blastape II." The 3M tape had been tested earlier during the strut cable wrap materials evaluation test program and had failed; so it was believed that two layers of the 3M tape and one additional layer of aluminum foil tape (Specification No. STW4-2543), both spiral wrapped with at least 50% overlap to render a total of 6 layers over the cable, would be adequate. This cable wrap was tested under identical conditions as were the other materials during the strut cable evaluation test program. The test model shown in Fig. 20 was mounted in Position 4 of the HGF test section. The temperature of the surface of the cable reached 300 F in 12 seconds and the test cable was destroyed (see Fig. 21) before the run was terminated at 14.8 seconds.

Fig. 20 - Rear View of Strut Cable Test Cylinder Model Showing Cable Wrapped  
with 3M and Aluminum Foil Tape and Strapped Around Cylinder

- The 3M Heat Barrier Tape, though easy to wrap cables with, is not as good as the "Blastape II" for thermally protecting the cables.
- Cables when buried under 3 in. of "Instafoam" would survive the heating predicted for thermal curtain failure, though it is not known how well it would take the aerodynamic and aero-shear forces.

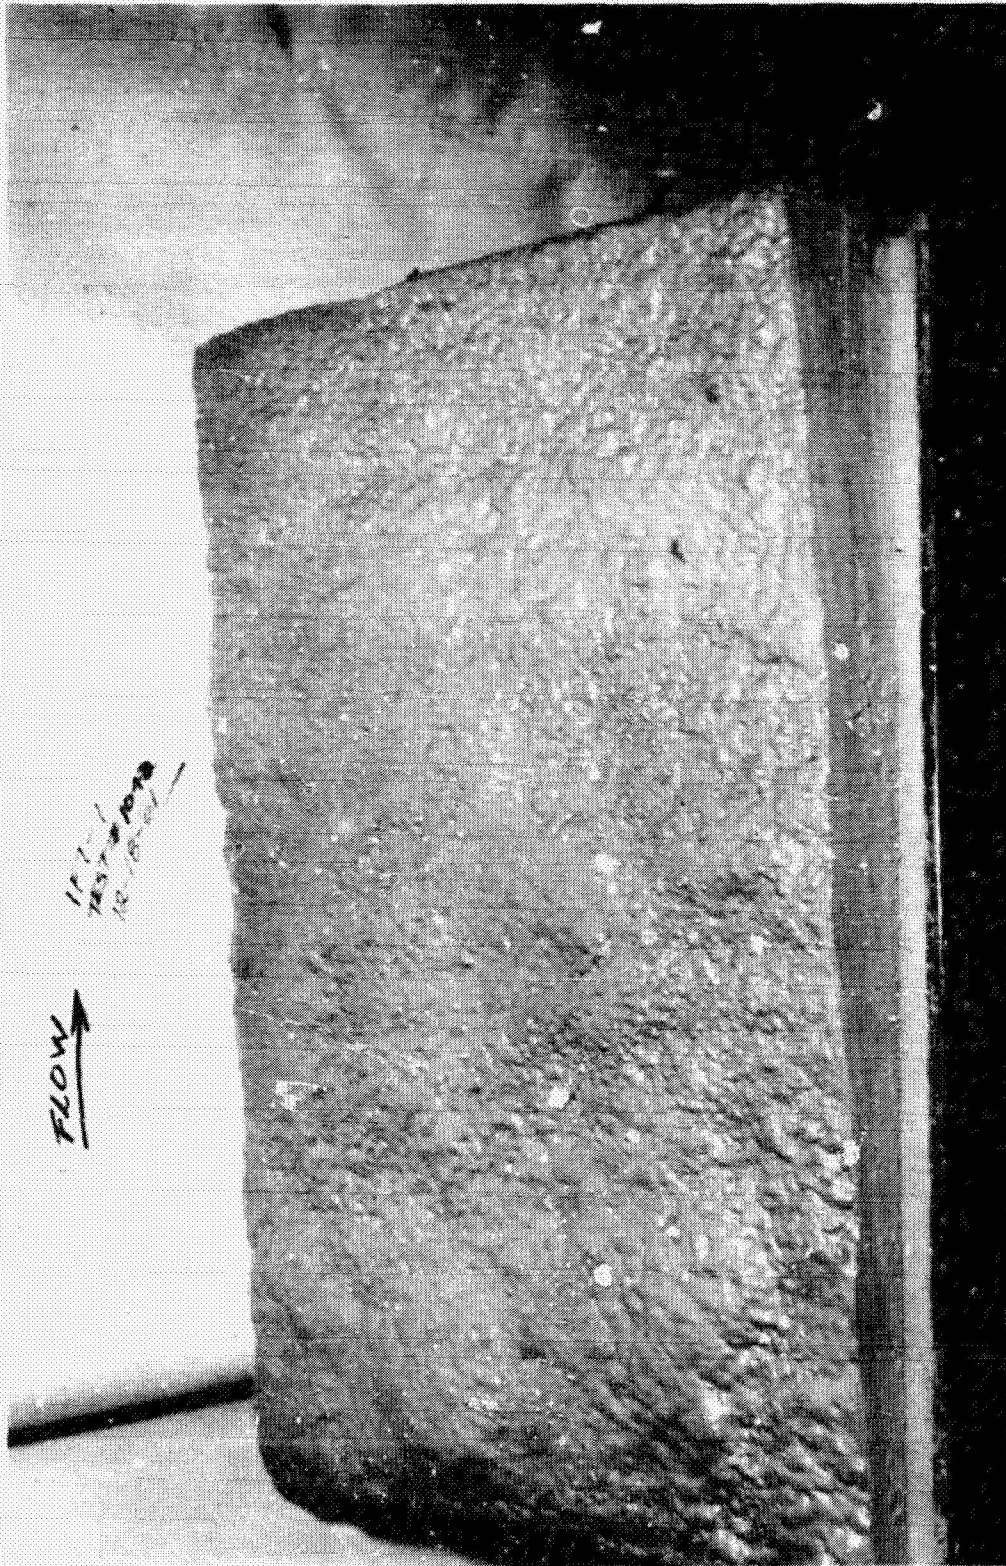
Figure 22 shows a ramp of "Instafoam" made up in a 3 in. deep steel pan that is 28 in. long and 22 in. wide. The pan carries assorted cables at its bottom, with a thermocouple attached to each one, buried in the foam. The pan was mounted in Position 1 of the HGF test section where the average heating rate on the ramp is estimated to be 11 Btu/ft<sup>2</sup>-sec. Fig. 23 shows the condition of "Instafoam" after 77 seconds of hot flow over it. The thermocouples did not respond since they were buried deep in the foam.

Fig. 22 - Insta-Foam over Cables Model
